Manhole Inspection Summary

Manhole # S17AA2006MH

Insp Date: **11/13/06 9:57 AM**

Location Address: **2009 ROGERS AVE**

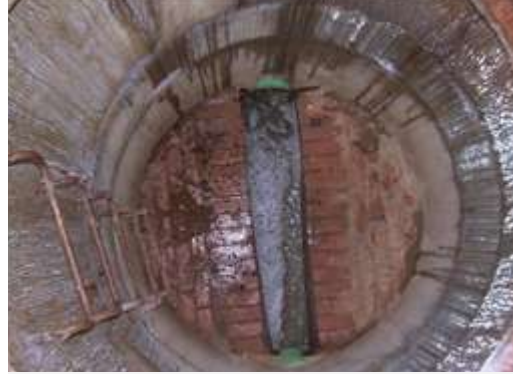
Top View

Bench ☒ Exists Material: **Brick** ☐ Parged ☒ **Debris** (not Condition related)

Channel Material: **Brick** ☐ Parged ☒ **Debris** (not Condition related)

Steps Count: **5** Missing: **0** ☒ **Corroded**

Corroded steps. Bench and Channel debris.

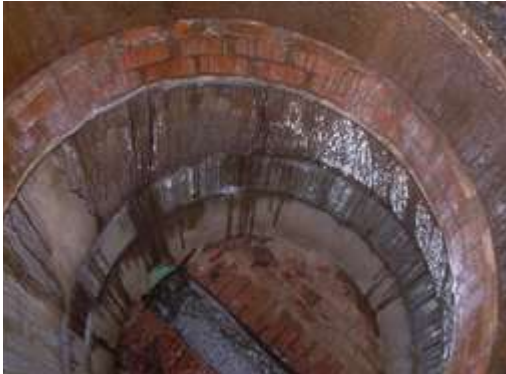
Defect

Frame Offset: **0** (in.) Condition: ☐ Sound ☐ Cracked ☒ **Leaks**

Infiltration: ☐ None ☒ **Joint** ☐ Cracks ☒ **Mortar** ☐ Roots ☐ Wall

Infiltration: ☐ None ☒ **Joint** ☐ Cracks ☐ Mortar ☐ Roots ☐ Wall

Frame leaks. Adjustment and Barrel infiltration.

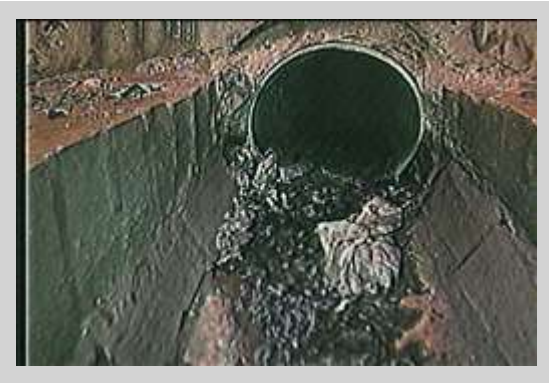
8 in. Circular Gravity Sewer Pipe Out @ 12 O'Clock

Channel and pipe debris.

Deposits: ☐ None ☒ **Mud** ☐ Sludge ☒ **Debris** ☐ Grease

Silt Depth: **2** (in.) Deposits Extent: **Light**

Infiltration: **Evidence** Pipe Seal Cond: **Unknown**

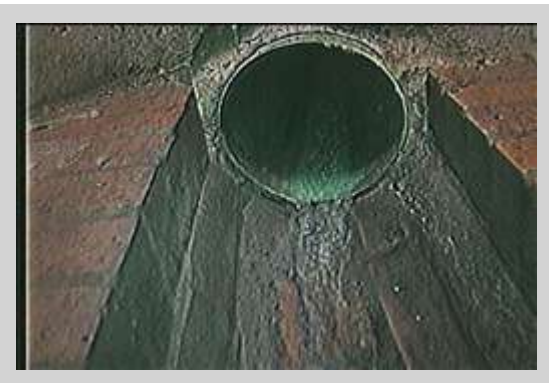
8 in. Circular Gravity Sewer Pipe In @ 6 O'Clock

Deposits: ☒ **None** ☐ Mud ☐ Sludge ☐ Debris ☐ Grease

Infiltration: **None** Pipe Seal Cond: **Unknown**
